REFERENCE: BOQ 149

ATTACHMENT TO M-6925
20 JUNE 1969
PAGE 1 OF 2

RUNWAY REPAIR
VINH AIRFIELD, NORTH VIETNAM
1844N 10540N
[REDACTED]

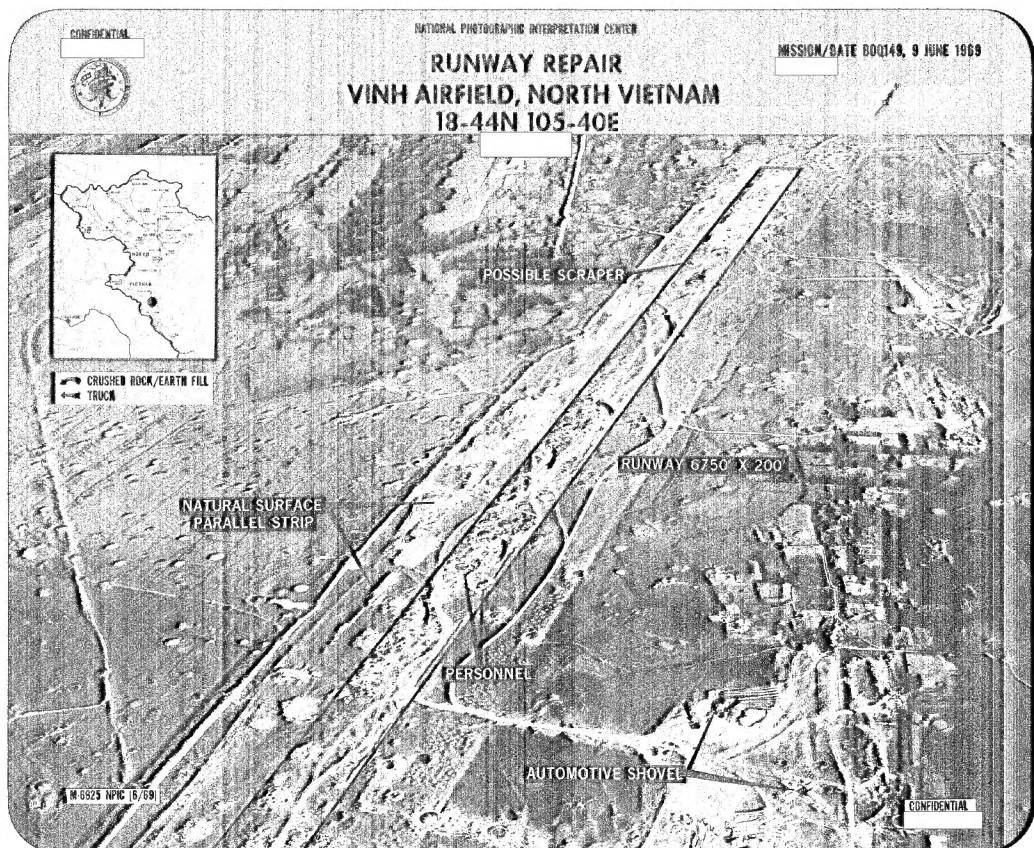
THIS BRIEFING BOARD DEPICTS INITIAL ATTEMPTS BY THE NORTH VIETNAMESE TO REPAIR THE RUNWAY AT VINH AIRFIELD.

PHOTOGRAPHY FROM BUMPY ACTION MISSION Q 149, 9 JUNE 1969, REVEALS INITIAL STAGES OF REPAIR TO THE 6750 x 200 FT, NORTH-SOUTH RUNWAY AT VINH AIRFIELD. REPAIR ACTIVITY PRIMARILY CONSISTS OF PERSONNEL BEING UTILIZED TO FILL CRATERS WITH CRUSHED ROCK AND EARTH. AT LEAST 15 CRATERS ARE BEING FILLED AND APPROXIMATELY 20 CRATERS HAVE CRUSHED ROCK/EARTH FILL PILED NEAR OR AROUND THEM. FOUR TRUCKS AND TWO AUTOMOTIVE SHOVELS ARE LOCATED ADJACENT TO THE EAST SIDE OF THE RUNWAY AND A POSSIBLE EARTH SCRAPER IS LOCATED TOWARD THE NORTH END OF THE RUNWAY. THE NATURAL SURFACE PARALLEL STRIP IS SERVICEABLE. NO AIRCRAFT ARE OBSERVED. SEVERAL OCCUPIED ANTI-AIRCRAFT ARTILLERY SITES ARE OBSERVED IN THE AREA OF THE AIRFIELD (NOT SHOWN ON GRAPHIC).
